[Docket No. FAA-2004-18744; Directorate Identifier 2004-CE-24-AD]

Airworthiness Directives; Great Lakes Aircraft Company, LLC, Models 2T-1A-1 and 2T-1A-2 Airplanes

ACTION: Notice of proposed rulemaking (NPRM).

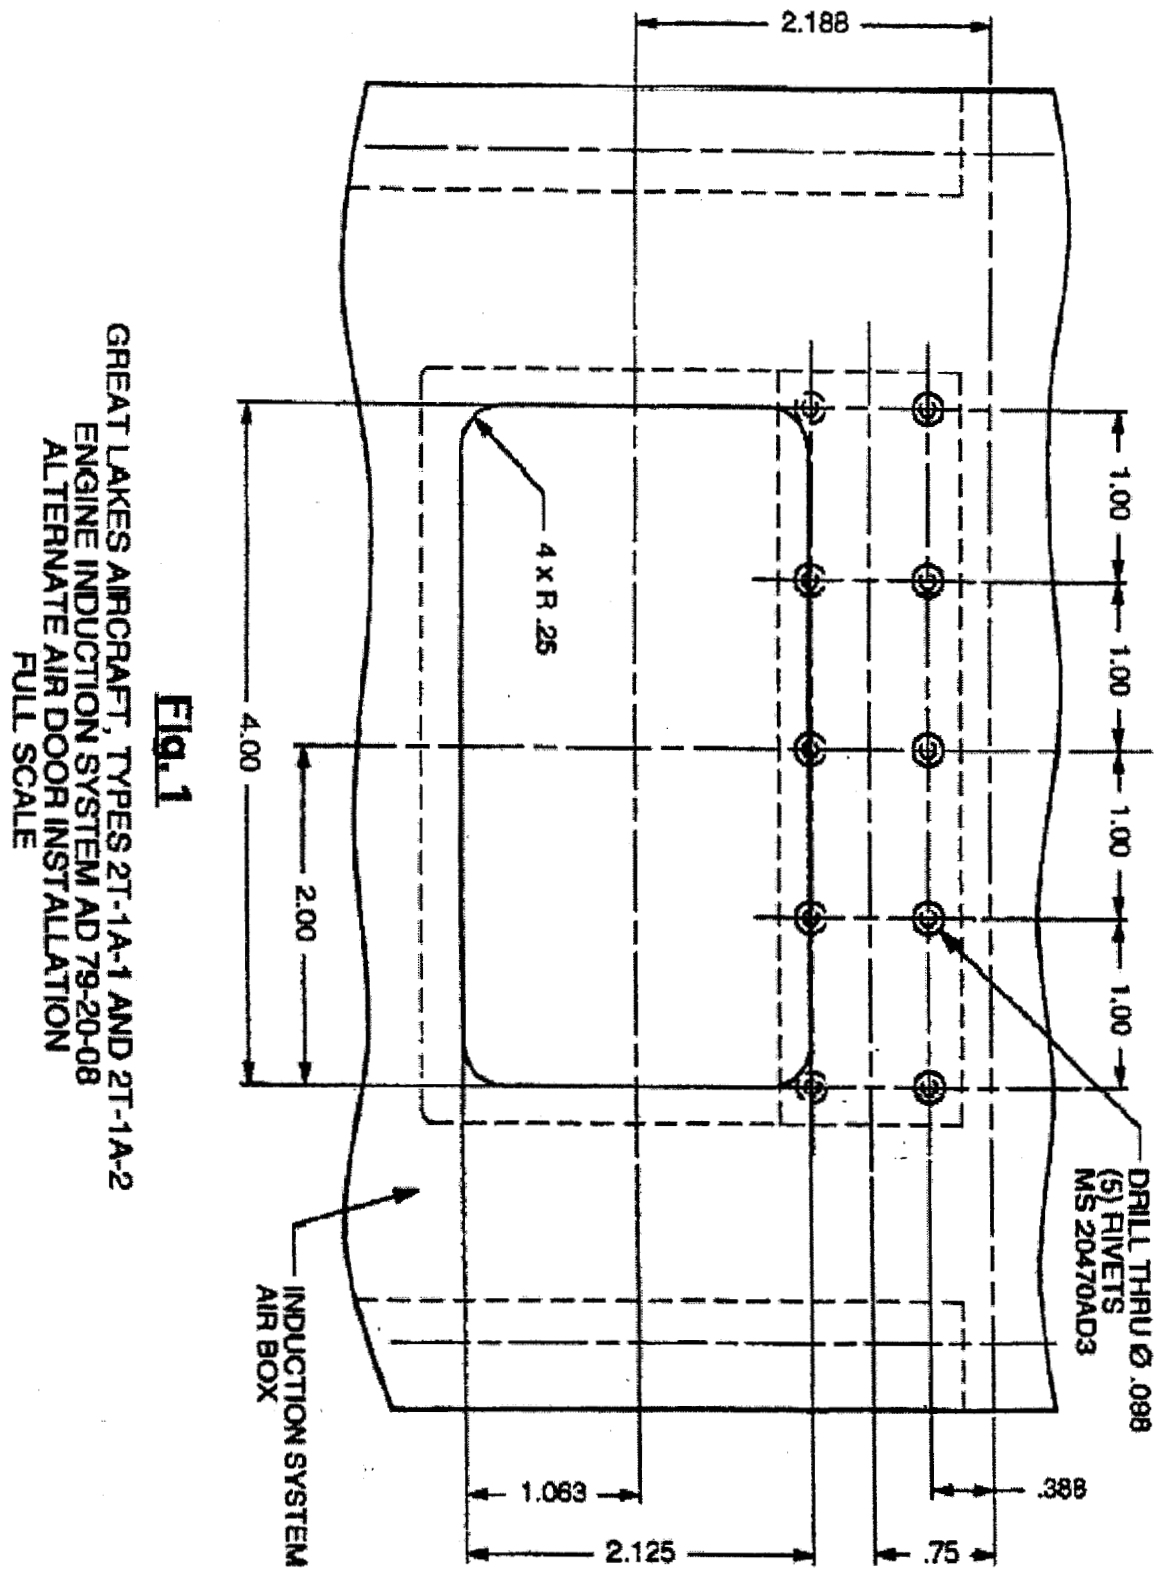
Figure 1

GREAT LAKES AIRCRAFT, TYPES 2T-1A-1 AND 2T-1A-2
ENGINE INDUCTION SYSTEM AD 79-20-08
ALTERNATE AIR DOOR INSTALLATION
FULL SCALE

Actions	Compliance	Procedures
<p>(1) Perform the following:</p> <p>(i) Visually inspect the aircraft induction system drain fitting located in the induction elbow below the fuel injector for blockage or restriction.</p> <p>(ii) If the hole is blocked or restricted in the weld area or not drilled through the elbow, open up the restricted hole or drill a hole in the elbow at the fitting location using a No. 10 (.193) drill.</p>	<p><u>For all affected airplanes:</u> Inspect within the next 25 hours time-in-service (TIS) after the effective date of this AD. Before further flight, modify the blocked or restricted aircraft induction system drain fitting.</p>	<p>Not applicable.</p>
<p>(2) Visually inspect the alternate air door for distortion, heat damage, and cracks. If any damage is found, repair or fabricate a new door following Figure 1, Figure 2, and Figure 3 in this AD.</p>	<p><u>For airplanes previously affected by AD 79-20-08:</u> Initially inspect at the next scheduled inspection required by AD 79-20-08 or within the next 25 hours TIS after the effective date of this AD, whichever occurs later. Repetitively inspect thereafter at intervals not to exceed 100 hours TIS. <u>For airplanes not previously affected by AD 79-20-08:</u> Inspect within the next 25 hours TIS after the effective date of this AD. Repetitively inspect thereafter at intervals not to exceed 100 hours TIS. <u>For all affected airplanes:</u> If damage is found during any inspection, before further flight, repair or replace the damaged alternate air door.</p>	<p>Not applicable.</p>

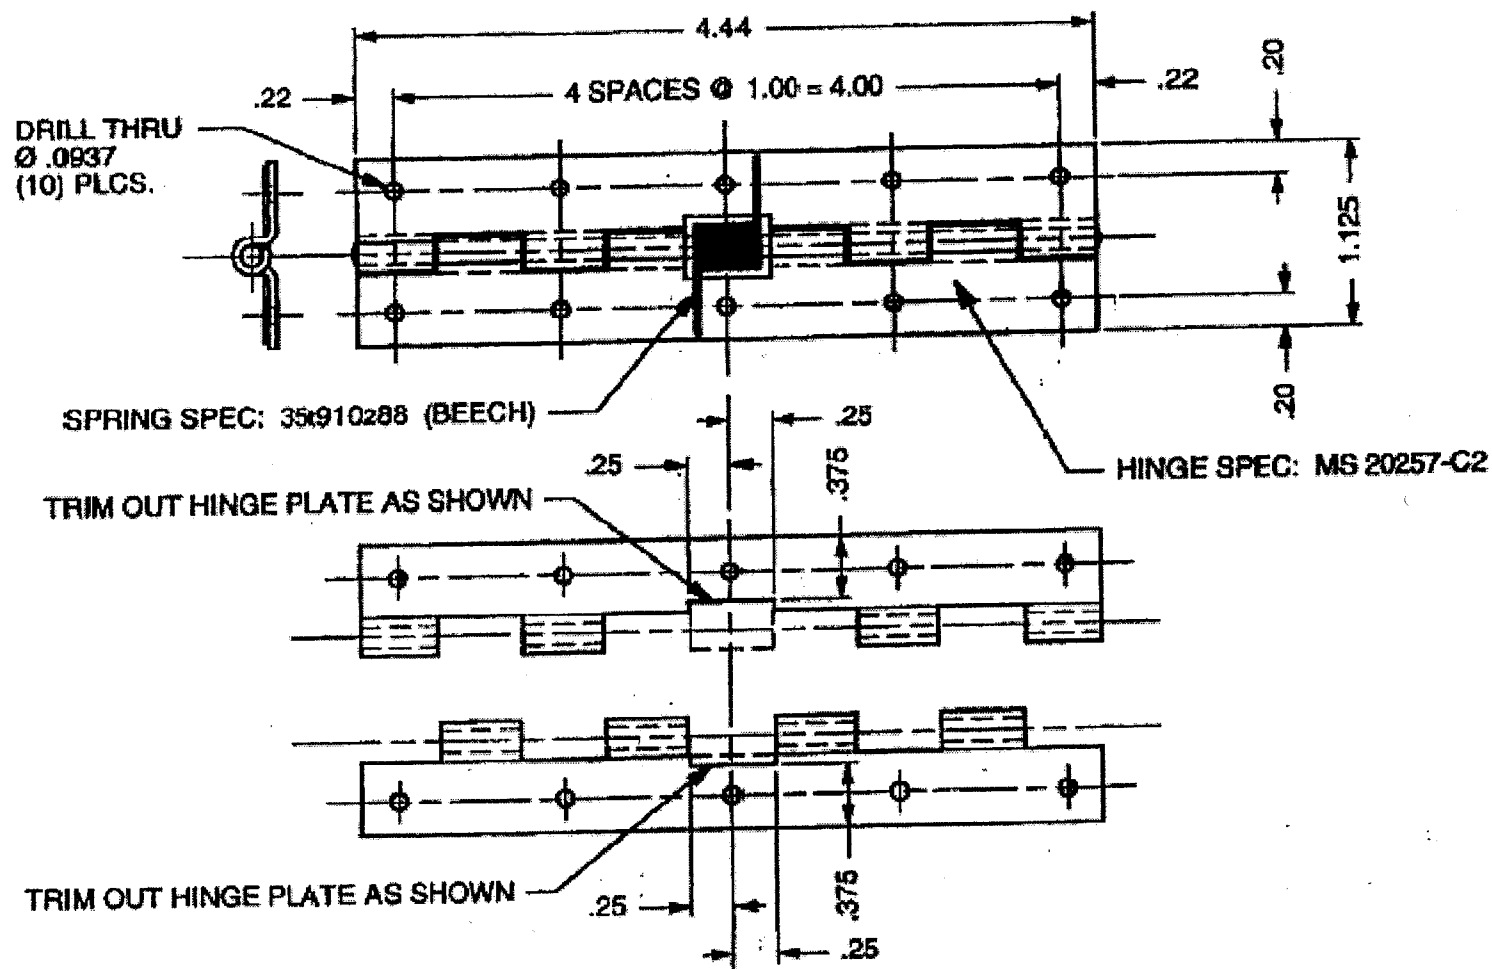
Figure 3

GREAT LAKES AIRCRAFT, TYPES 2T-1A-1 AND 2T-1A-2
ENGINE INDUCTION SYSTEM AD 79-20-08
ALTERNATE AIR DOOR HINGE DETAIL
FULL SCALE
